Manhole Inspection Summary

Manhole # S11E1_012MH

Insp Date: **4/9/08 11:19 AM**

Location Address: **1420 Joh Ave**

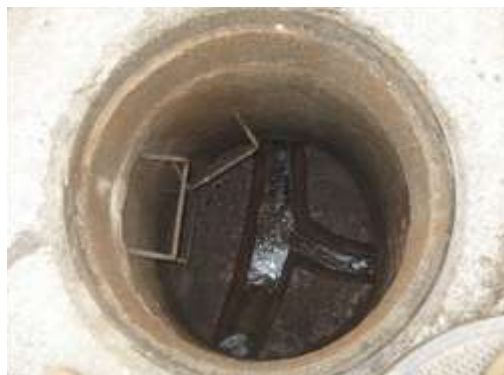
Top View

Debris on bench and channel

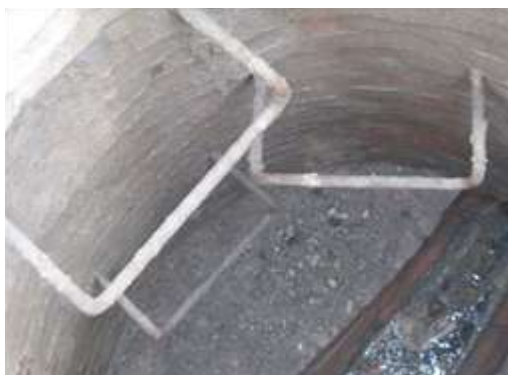
Defect 1

Infiltration: ☐ None ☐ Joint ☐ Cracks ☐ Mortar ☐ Roots ☒ **Wall**

Count: **3** Missing: **0** ☒ **Corroded**

Corroded steps/Barrel infiltration

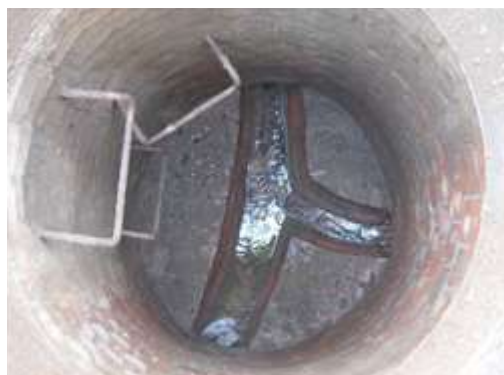
Defect 2

Infiltration: ☐ None ☐ Joint ☐ Cracks ☐ Mortar ☐ Roots ☒ **Wall**

corbel and barrel infiltration

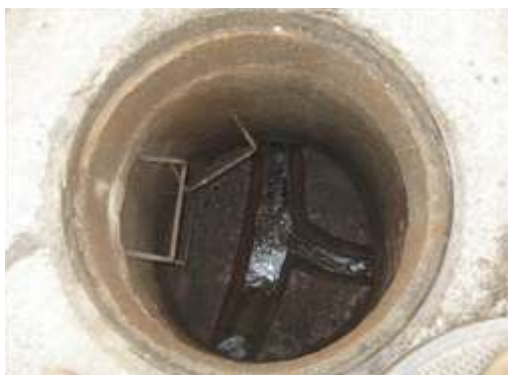
Defect 3

Offset: **0.5** (in.)

☒ **Leaks**

Infiltration: ☐ None ☐ Joint ☐ Cracks ☐ Mortar ☐ Roots ☒ **Wall**

chimney infiltration, offset & frame leaks

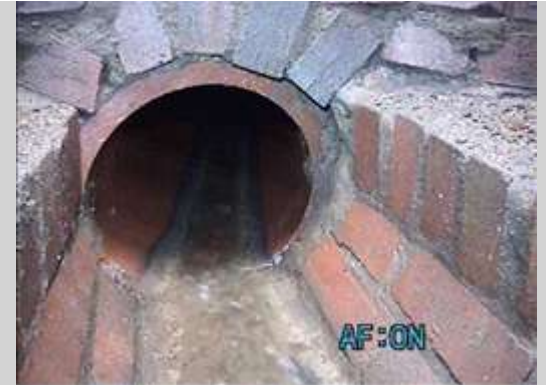
12 O'Clock Outflow

10 in. Circular Gravity Sewer
Pipe Out @ 12 O'Clock

Pipe Height: **9.6** (in.) Rod and Bar (Angled)
Pipe Material: **Clay** ☐ Pipe Lined
Invert Depth: **7.06** (ft.) Flow Characteristics: **Fast**
Deposits: ☒ None ☐ Mud ☐ Sludge ☐ Debris ☐ Grease
Silt Depth: **0** (in.) Deposits Extent:
Infiltration: **None** Pipe Seal Cond: **Sound**

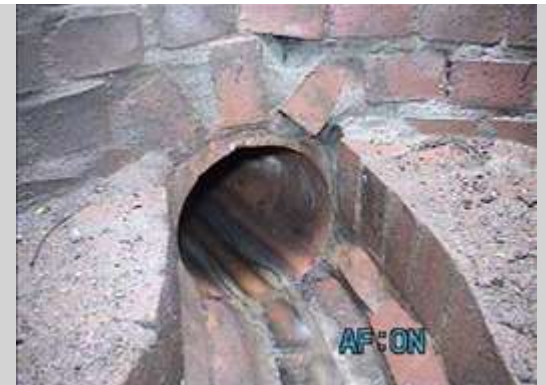
4 O'Clock Inflow

8 in. Circular Gravity Sewer
Pipe In @ 4 O'Clock

Pipe Height: **8.4** (in.) Rod and Bar (Angled)
Pipe Material: **Clay** ☐ Pipe Lined
Invert Depth: **6.72** (ft.) Flow Characteristics: **Fast**
Deposits: ☒ None ☐ Mud ☐ Sludge ☐ Debris ☐ Grease
Silt Depth: **0** (in.) Deposits Extent:
Infiltration: **None** Pipe Seal Cond: **Sound**

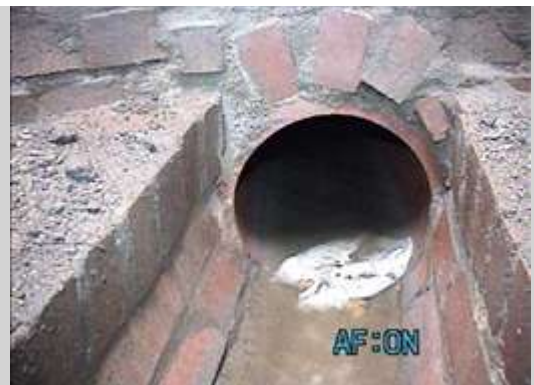
7 O'Clock Inflow

10 in. Circular Gravity Sewer
Pipe In @ 7 O'Clock

Pipe Height: **10.8** (in.) Rod and Bar (Angled)

Infiltration: **None** Pipe Seal Cond: **Sound**
